# **An Assessment of Streambank Stabilization and Riparian Restoration Efforts at Buffalo National River, Arkansas**

**Prepared By:**  
**David N. Mott, Hydrologist**  
**and**  
**Tony Collins, Hydrologic Technician**  
**National Park Service**  
**Buffalo National River**

February, 2002

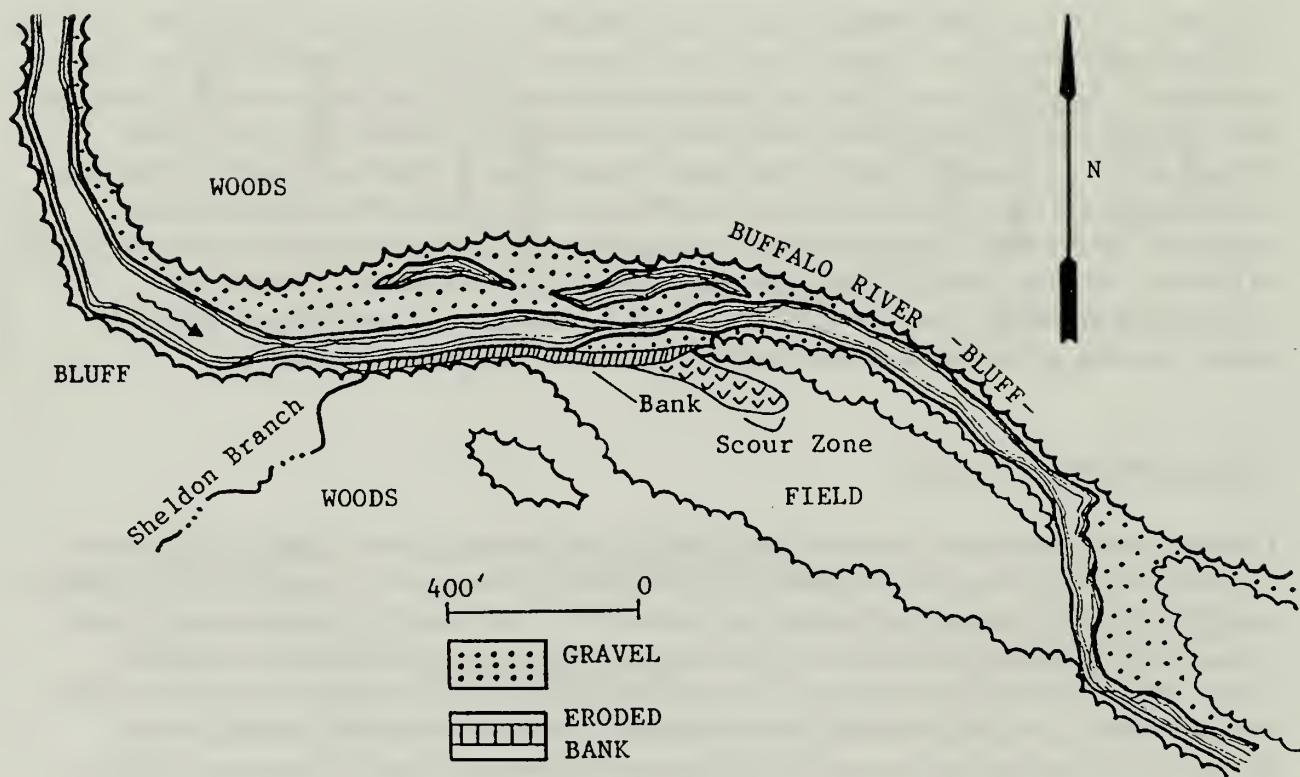
Overbank scour sites form only in areas where the riparian corridor has been eliminated and where the river can "short cut" across a floodplain. The Sheldon Branch field erosion site is a classic example of this process. The map in Figure 7 shows the planview form representation of the Sheldon Branch Field. When flood waters top an already eroding bank on the upstream end of the floodplain, the high velocity waters encounter nothing to slow them down or to stabilize and bind the flood plain soils. The turbulence generated at the contact between the floodplain and the streambank tears massive amounts of soil from the top of the bank, often depositing hundreds of cubic yards of sediment further out in the floodplain. Where this overbank flow re-enters the river, channel erosion also takes place, although it generally does not appear to be as severe as along upstream banks.

Figure 7: The Sheldon Branch Site as an example of overbank scour.

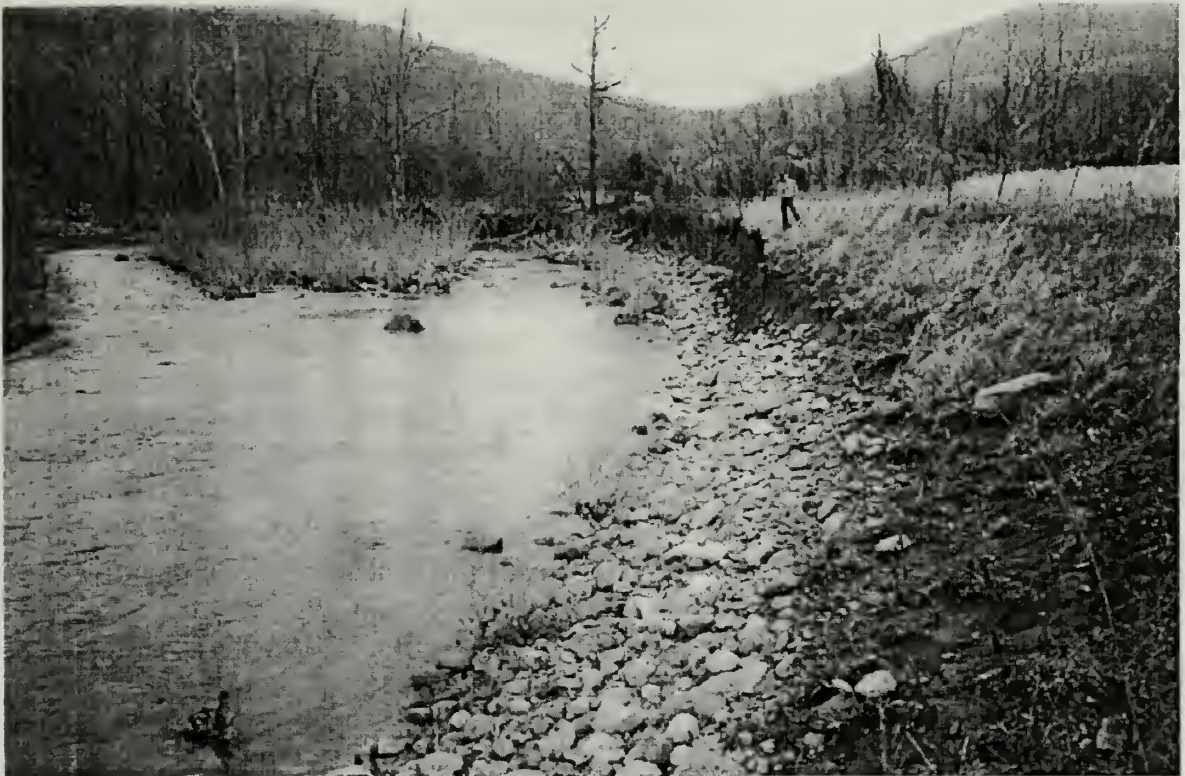
**Photo 1: Lower half of the Wilderness Boundary Site (1994).**

This site is still eroding, but appears to be slowly stabilizing. There are sycamores and willows populating the bank along the toe of the slope. The downstream portion of the site has eroded an additional 15 feet. The thalweg appears to be moving out away from the bank. There is also a dense growth of annual vegetation covering the top of the bank. This site provides an example that the most important factor in restoration is removal of the disturbance. Often given enough time, the reach can stabilize on its own. However, it should be noted that the in-stream gravel mining occurred over 30 years ago at this site, but recovery, while ongoing, is far from complete.

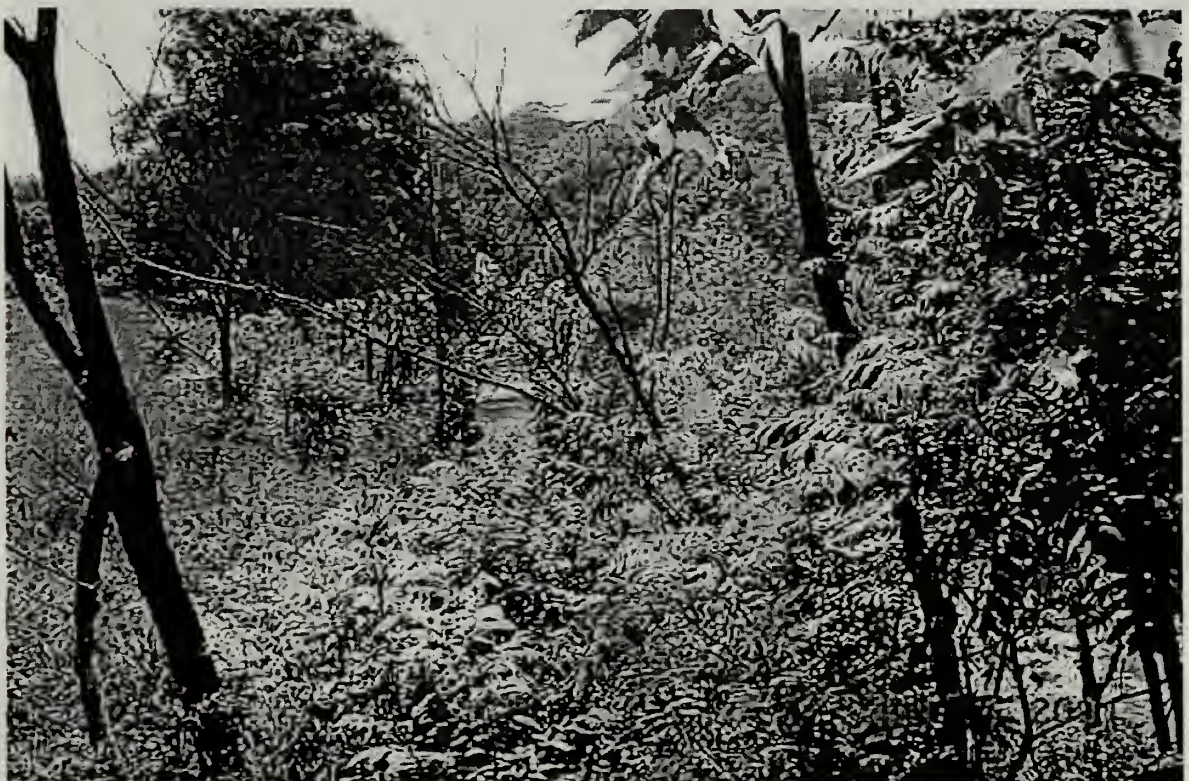
Photo 6: View down stream of Beech Creek Site (2001).

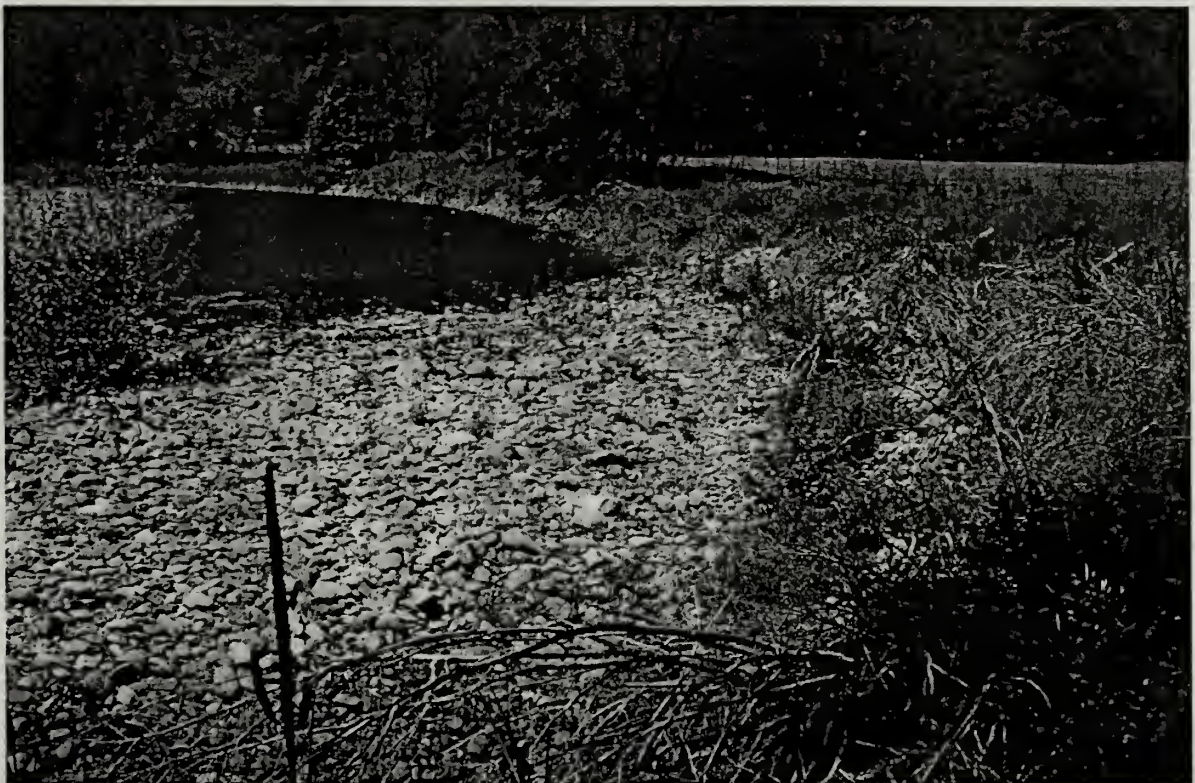
Overall Summary – The bank is stable and supporting vegetation. The thalweg is running along the revetment on the upstream 2/3 of the bank. The downstream 1/3 of the bank has good growth of willows and juvenile sycamores along the toe and between the stream and the bank. The bank slope is supporting moderate annual vegetation and a variety of native tree growth. As can be seen in the cross section survey of this site (Appendix A) the main channel is moving from the channel in front of the bank into the overflow channel on river right across from the bank. Although the revetment had to be rebuilt due to age, stream velocity in this headwaters reach, and other factors have not allowed a great deal of natural vegetation to populate the bank and it is our opinion that given time this bank will stabilize. Private property is located just beyond the bank causing us to put extra effort into stabilizing this eroding cutbank.

**Photo 11: Upstream view of Ferguson revetment (2001).**

The downstream portion of the bank was back sloped to a 1:1 slope and a two row cedar tree revetment was installed along the entire length of the bank in 1995. The upstream portion of the bank was not back-sloped due to other resource considerations. Native river cane was planted along the face of the back-sloped bank and an attempt was made to transplant hardwood saplings along the top of the slope. Native hardwood seedlings were planted inside the riparian buffer on an 8X8 foot spacing. Due to an extreme flood event, repairs on the revetment were made in 1996. Cedar trees were replaced on the entire revetment in 2001 using most of the existing anchors.

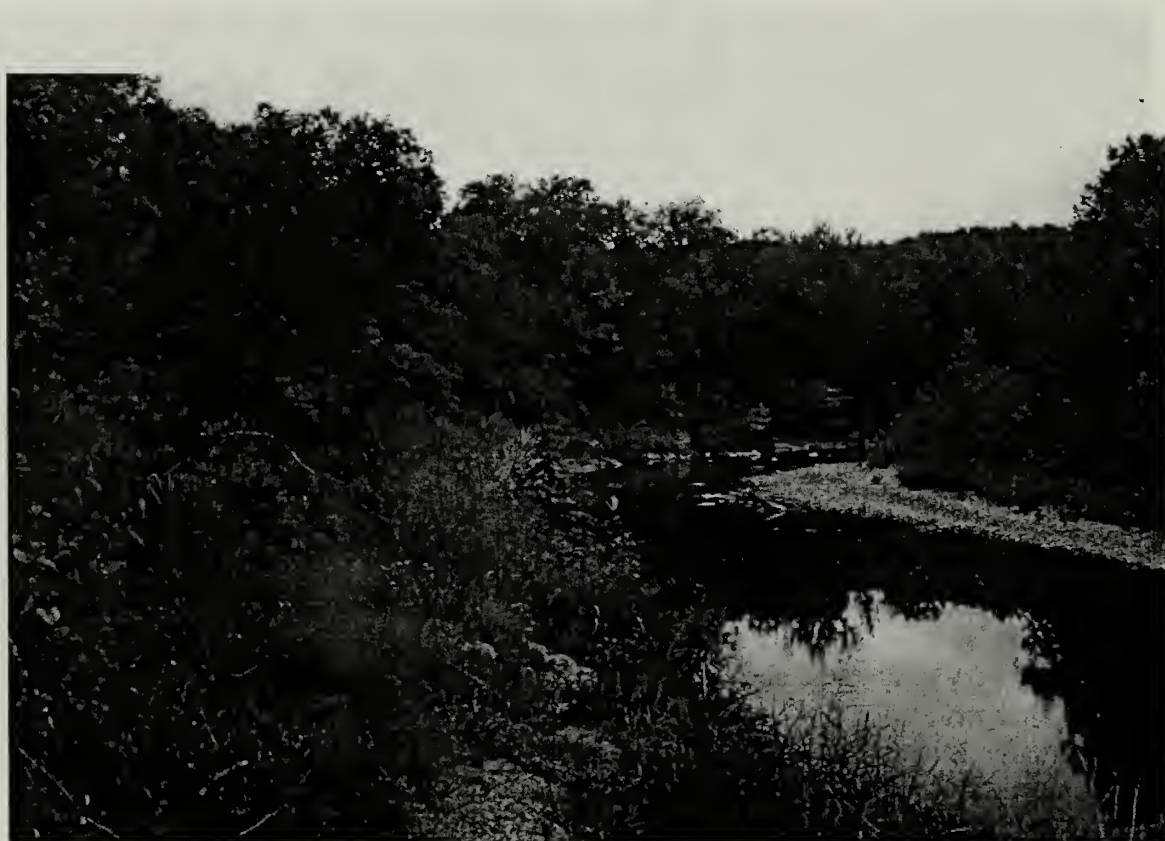
**Photo 16: View downstream of the lower portion of the Angle Field Site (2000).**

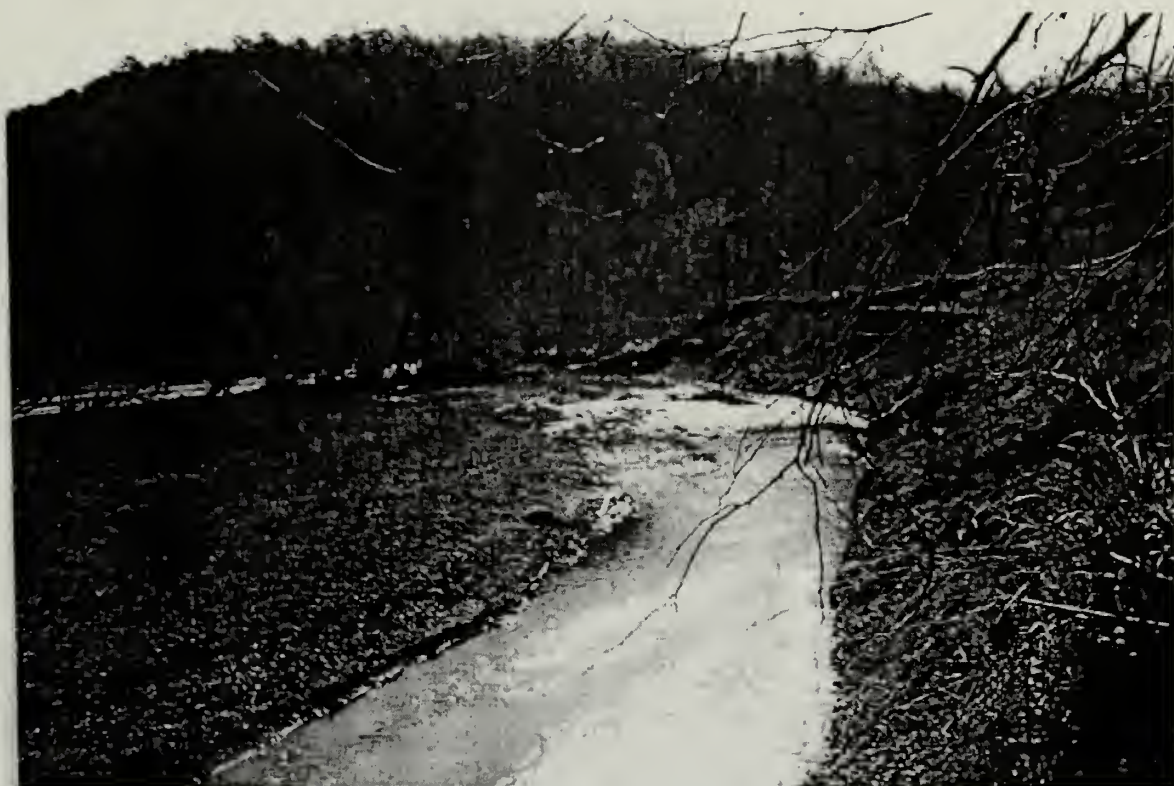
The site is located immediately above the confluence of Rock Creek with the Buffalo River (Figure 5). The bank top has been cleared for agricultural use. The eroding bank at the project site is 14 feet tall and 250 feet long. The channel shape is very uniform with a tall cut bank on the right side and a very low point bar on the other. The site is affected by backwatering and other processes associated with confluence sites. The bed material is dominantly gravel with very little cobble and a few isolated clumps of resistant clay. The bank is composed of silty sand with some clay layers. The lower portion is dominated by gravel with several gravel layers occurring nearly half way up the bank. These gravel layers are often covered by slump sand. The riparian corridor is thin throughout the length of this stream as it runs along the agricultural use area. At the eroding bank the thin wooded buffer has been breached leaving only unconsolidated sediments to counter erosional forces. Upstream/downstream control is chaotic and variable and is very dependent on backwatering process as driven by the Buffalo River. The dominant erosion processes are scour at the toe and slumping, which are driven by the lack of vegetation on the bank and flood plain, the steep angle of the bank and the variable strata. The erosion rate is estimated to be approximately 3.5 feet per year as determined from the 1972 and 1992 aerial photographs. Ground monitoring from 1985 through 1991 indicated an erosion rate of nearly 7 feet per year.

**Photo 17: View downstream of Lower Rock Creek Site (1994).**

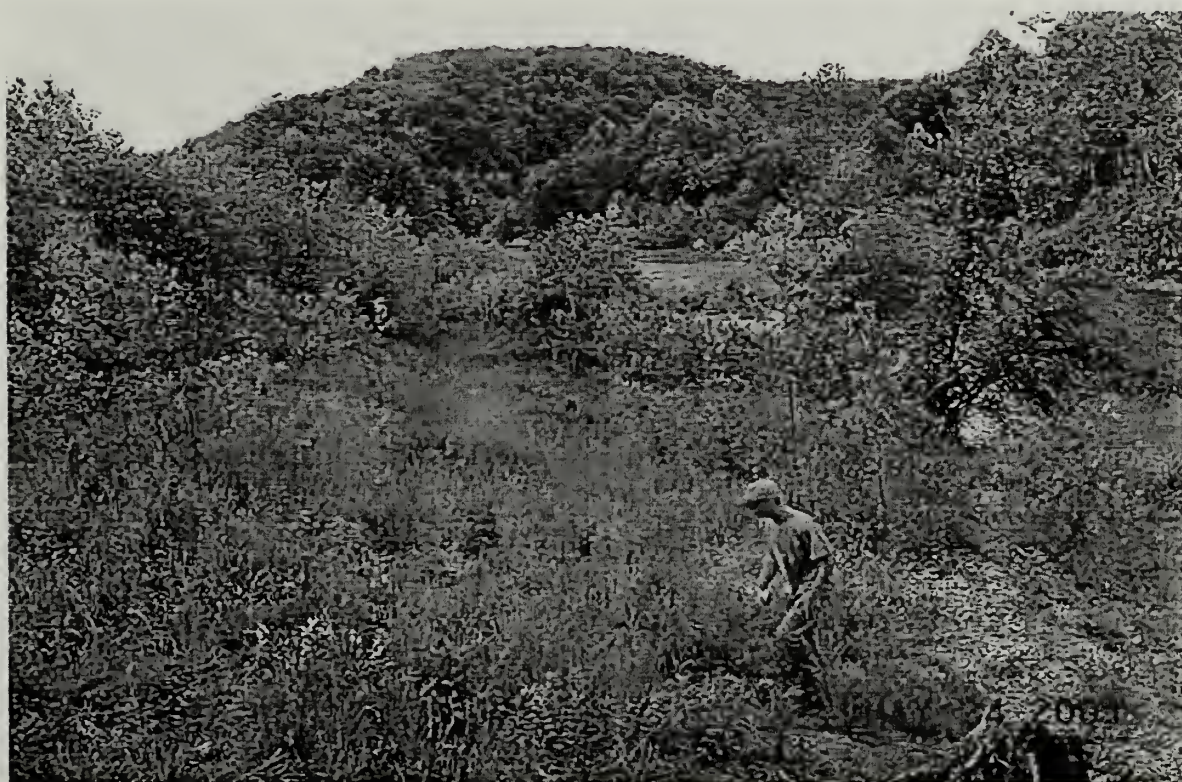
**Photo 23: View upstream of the Sheldon Branch Site (2001).**

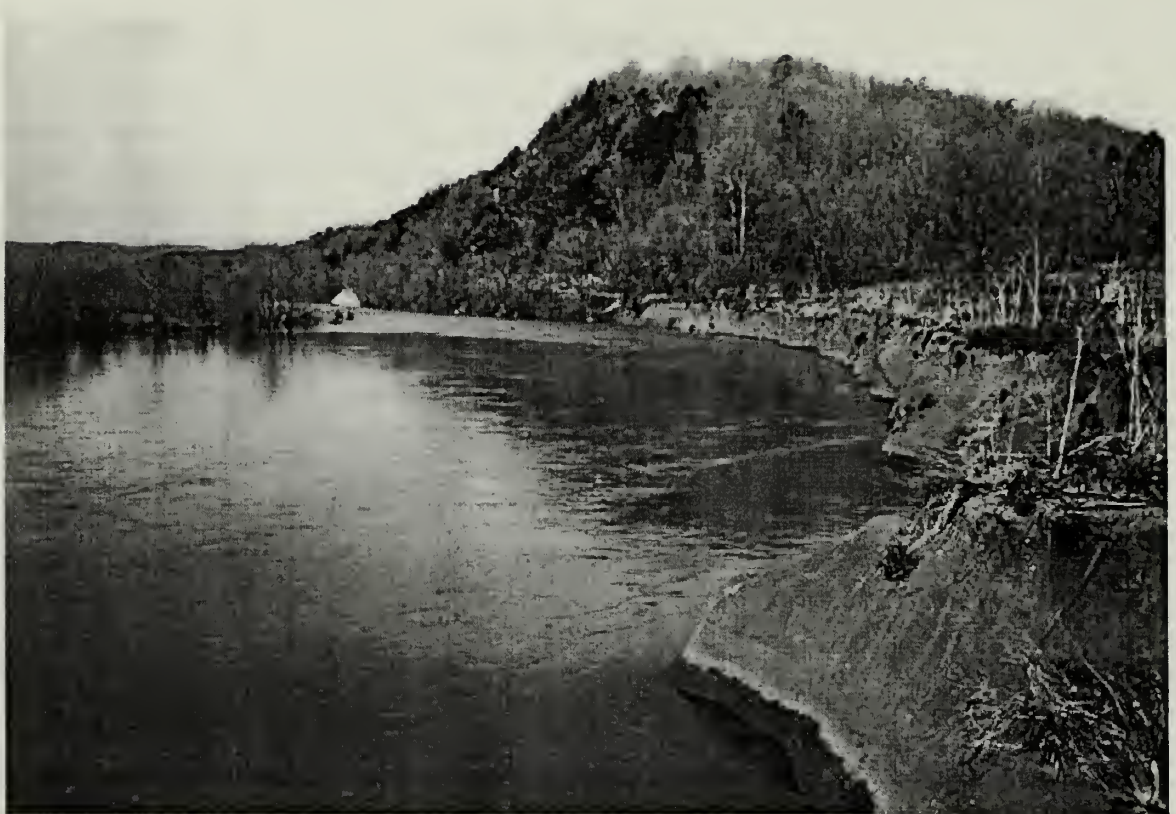
This site is located on the main channel of the Buffalo River just above Jamison Creek. The eroding bank is 12 feet high and 2340 feet in length. Upstream of this site the river has eroded up against the Woolum road and the adjacent bluff. BUFF's maintenance division has constructed a massive hard structure about 100 yards above the eroding bank to prevent slumping and erosion of the road. Slumping, scour, block failure, and over bank flow scour are all active processes along this bank. The middle and lower portion of the bank has an undulating or corrugated morphology which encourages eddy currents and scour. Downstream at the lower end of the bank the river is controlled vertically by a shelf of bedrock, which helps force the lateral erosion process into this naked bank. The channel is very unstable, over widened, and forming a braided pattern toward the lower one-half of its length. Approximately ten different islands and a dozen flow routes have formed in the lower channel. Bed material is dominantly gravel size chert with some cobbles. The bars and islands in the lower portion of the channel have thick growths of willows attempting to stabilize them. The bank material is composed of silty sand with some clayey lenses and gravel in the lower 4 or 5 feet. Erosion rates have been documented as high as 24 feet per year along the middle and lower stretches of the bank from field measurements taken between 1985 and 1991. Average erosion rates as estimated from this work and aerial photographs are 14 feet per year over a 20-year period for the middle and lower section and between 2 and 4 feet per year for the upper 700 feet. The riparian corridor has been completely destroyed by past agricultural activities on both banks. Fields of fescue and milkweed are the only vegetation left on the tops of the banks. Cattle still have access to the river and the riparian corridor on the far bank and can wander across the river and up the eroding bank. The lower terminus of this bank is cutting in and under a healthy riparian forest.

**Photo 25: Upstream of upper portion of the Jamison Creek Site (1994).**

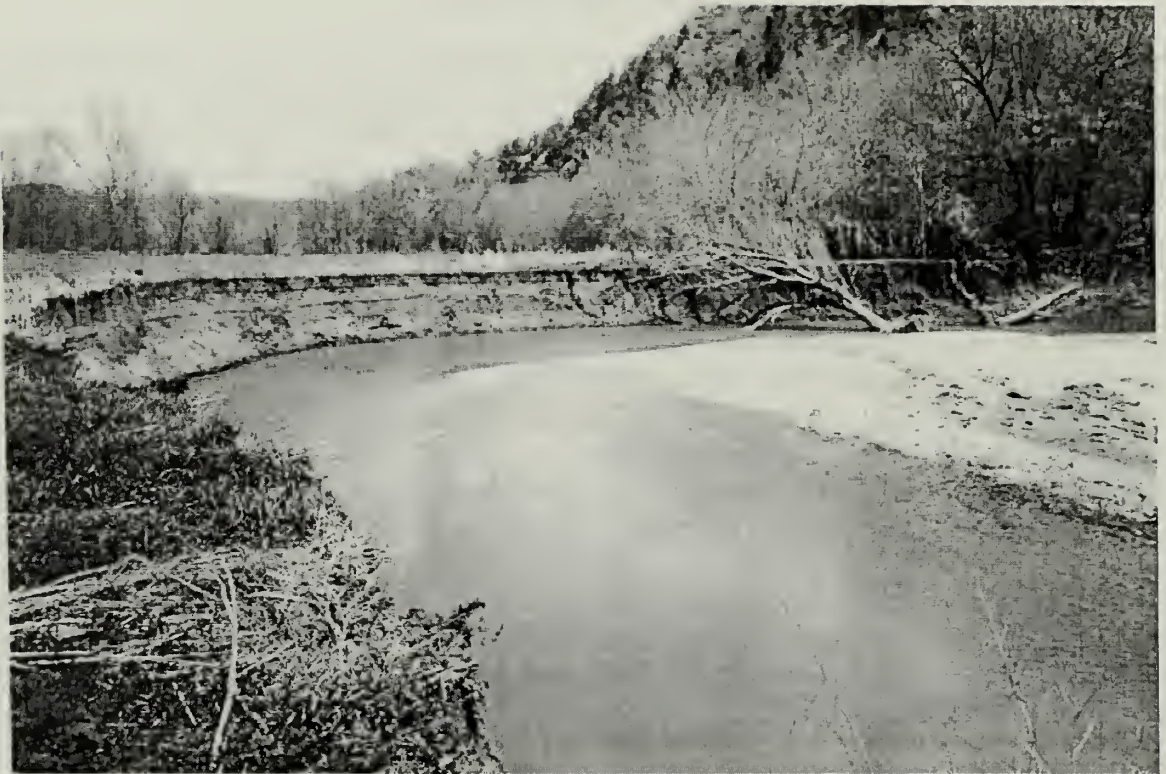
This site is located on Calf Creek approximately 600 feet above its confluence with the Buffalo River. The length of the bank without any buffer is 400 feet while another 100 feet of bank extends as an undercut below the downstream buffer. The bank averages about 12 feet high. The channel has a classic point bar to cut bank profile. Undercutting and scour at the toe combined with slaking and block failure are the dominant erosional processes acting on this rapidly eroding bank. The bed is composed of gravel, as is the slip off slope on the other side of the eroding bank. The bank is migrating so rapidly that very little recruitment of vegetation has occurred on the point bar. The cut bank is composed of very well consolidated sandy silt with gravel and cobbles at the toe. There is a layer of bedrock visible in the rapids at the downstream end of the eroding bank. The creek appears to be trying to cut around this layer of vertical control similar to what the river is doing at the Jamison Creek disturbance zone. The right bank has lateral bedrock control just downstream from the site. No upstream vertical control is visible and the healthy riparian corridor appears to be keeping the channel stable in the lateral sense. The rate of erosion is increasing at this site. Based on erosion measurements from aerial photographs the bank moved approximately 150 feet from 1972 to 1992 (7.5 feet per year), and from ground measurements approximately 125 feet from 1991 to April 1994 (39 feet per year). The streamside vegetation was just beginning to be breached on the 1972 aerial photographs. Since that time the erosion has progressed rapidly and is destroying the well-vegetated corridor downstream from this site. The upstream corridor is very dense and appears to be stable.

**Photo 31: View downstream of the Calf Creek Site (1994).**

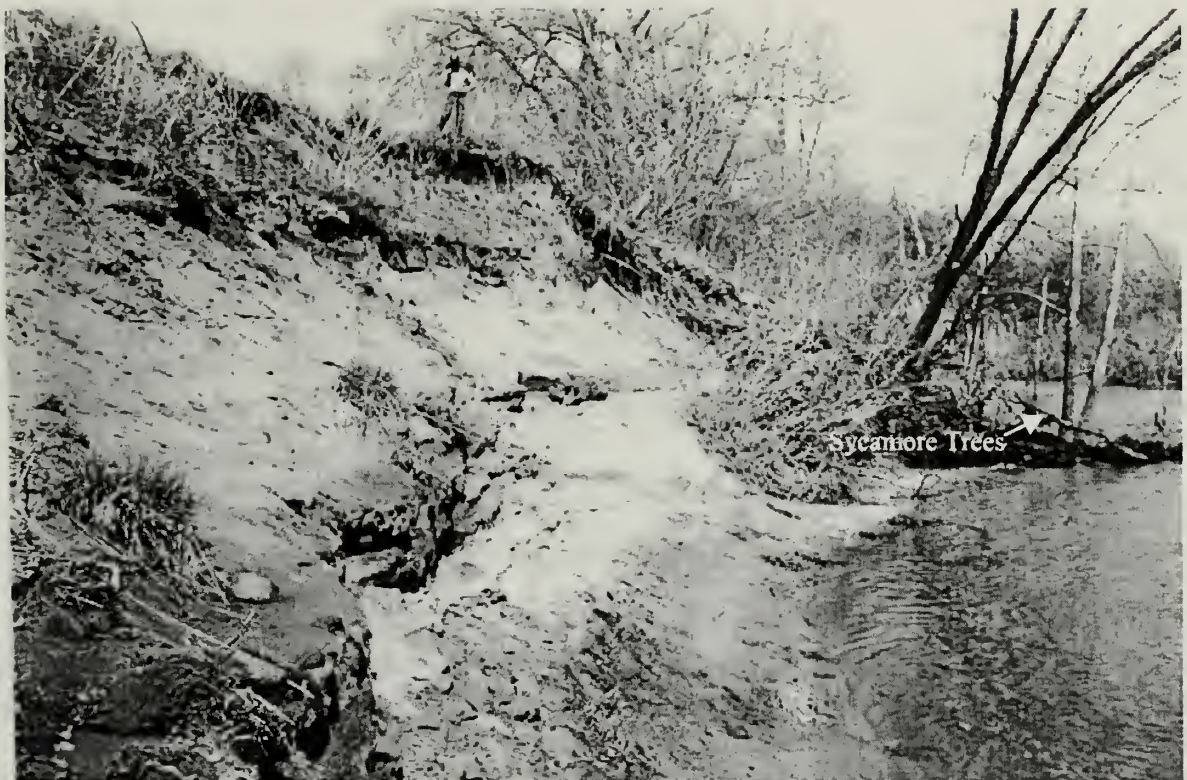
This site is located on the main channel of the Buffalo River. The bank is approximately 20 feet high and 420 feet in length. This is a classic example of a too narrow corridor of streamside vegetation that slumped catastrophically. Fortunately, the streamside above this point is characterized by a gentle slope that will probably resist slumping although the buffer is too thin. The area of the bank that has slumped has no trees along it and thus will have a hard time revegetating due to the lack of seed sources and rill erosion and other factors constantly working on the naked bank. The area of buffer below the bank is too thin and fairly steep in profile. It is probably a good candidate for continued slumping. This bank failed catastrophically during a flood in 1991. Approximately 50 feet of the bank went all at once during this rapid rise and fall of the hydrograph. Ground based monitoring has only recently been implemented at this site. As with most of the river channel in the middle and lower river, the bed is composed of gravel with cobbles interspersed. The bank is composed of very unconsolidated silty sand, loose sand and minor layers of clayey sand. The channel has a very stable profile above the slump area. On the opposite side of the bank is a gravel bar that has some variable sized emergent vegetation such as willows and appears to be quite stable as viewed on the aerial photographs. Massive slumping was the dominant process and is probably going to occur again on the lower bank. The naked part of the bank is now being impacted by scour during high water and rill during heavy rains that can easily move the unconsolidated sand composing this bank. If these processes continue the bank will eventually develop a more vertical profile, become unstable when loaded with water, and the slumping process will be repeated.

**Photo 33: View downstream of the Grinders Ferry Site. (1994)**

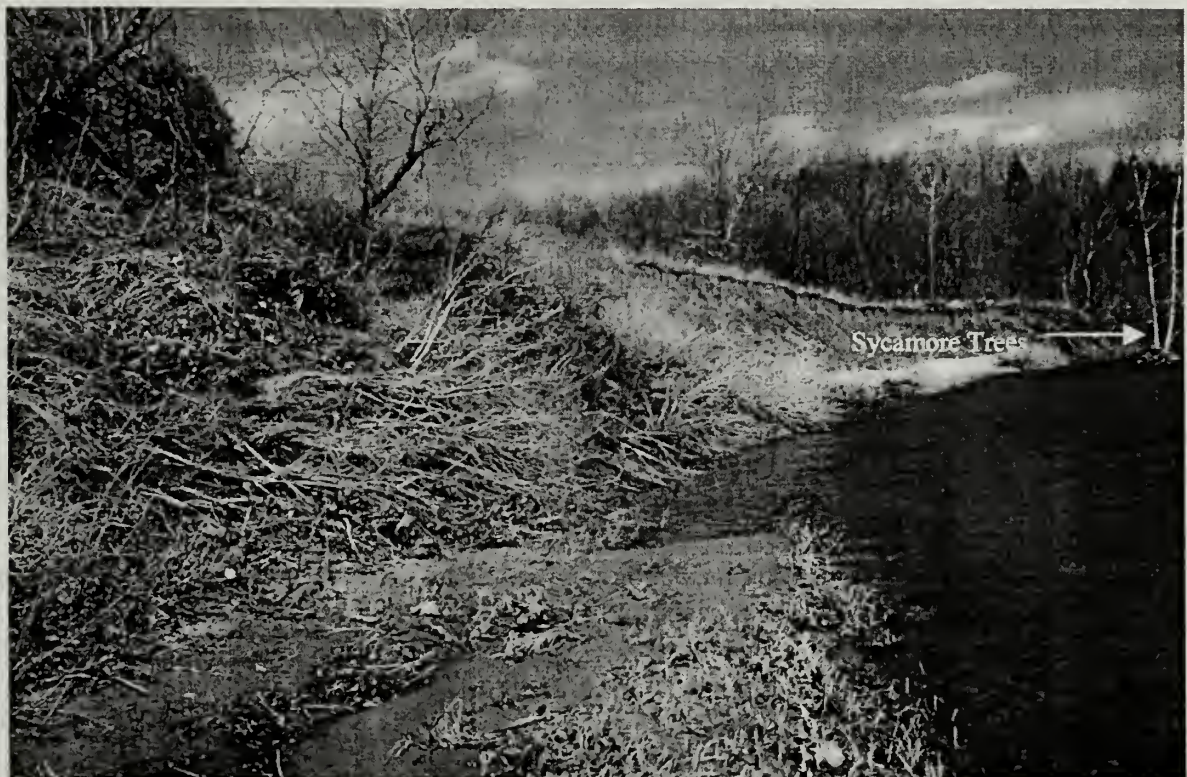
**Photo 34: View downstream of the Grinders Ferry Site (2000).**

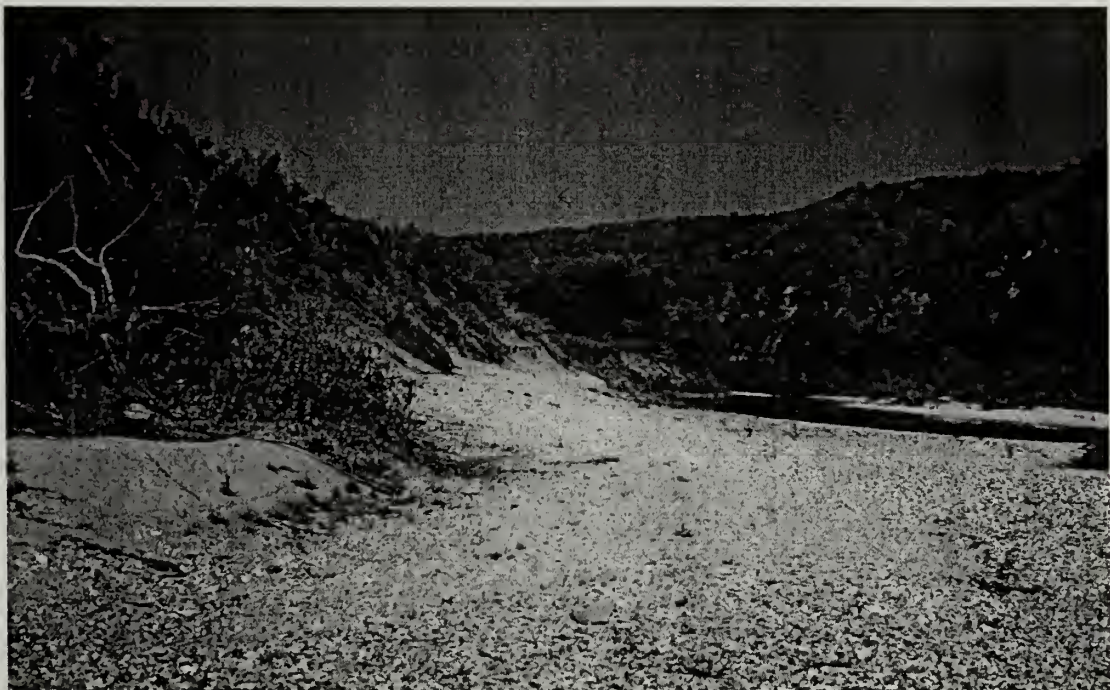
**Lower Third** – More than one half of the lower third is completely gone and continues to erode.

**Photo 37: View looking upstream at lower portion of South Maumee Site (2001).**

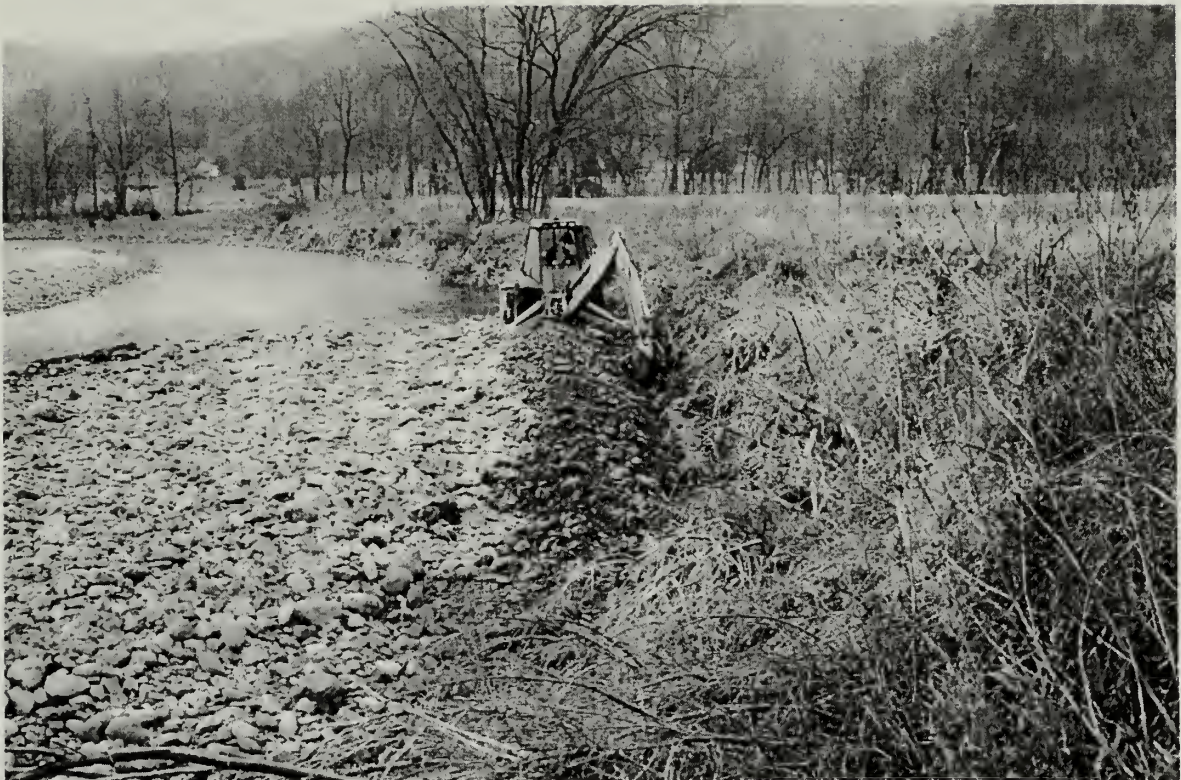
**Photo 38: Trench dug horizontally along toe bank for willow transplanting.**

Our next experimentation phase involved attempting whole willow transplanting one more time, but doing the work in the dormant season. We returned to the Ferguson site in February during a window of low-flow conditions. Approximately 40 individual willow plants were transplanted into a 75 feet long trench. The trench was excavated to a depth below the lowest level of summer flow. The bushy portions of the willow plants were not removed. When spring came, all of the willows leafed out, survived the first summer, and displayed vigorous growth. The willow trench also helped to protect the lower end of the Ferguson revetment and provide hydraulic roughness and encourage a depositional environment (Photo 31).

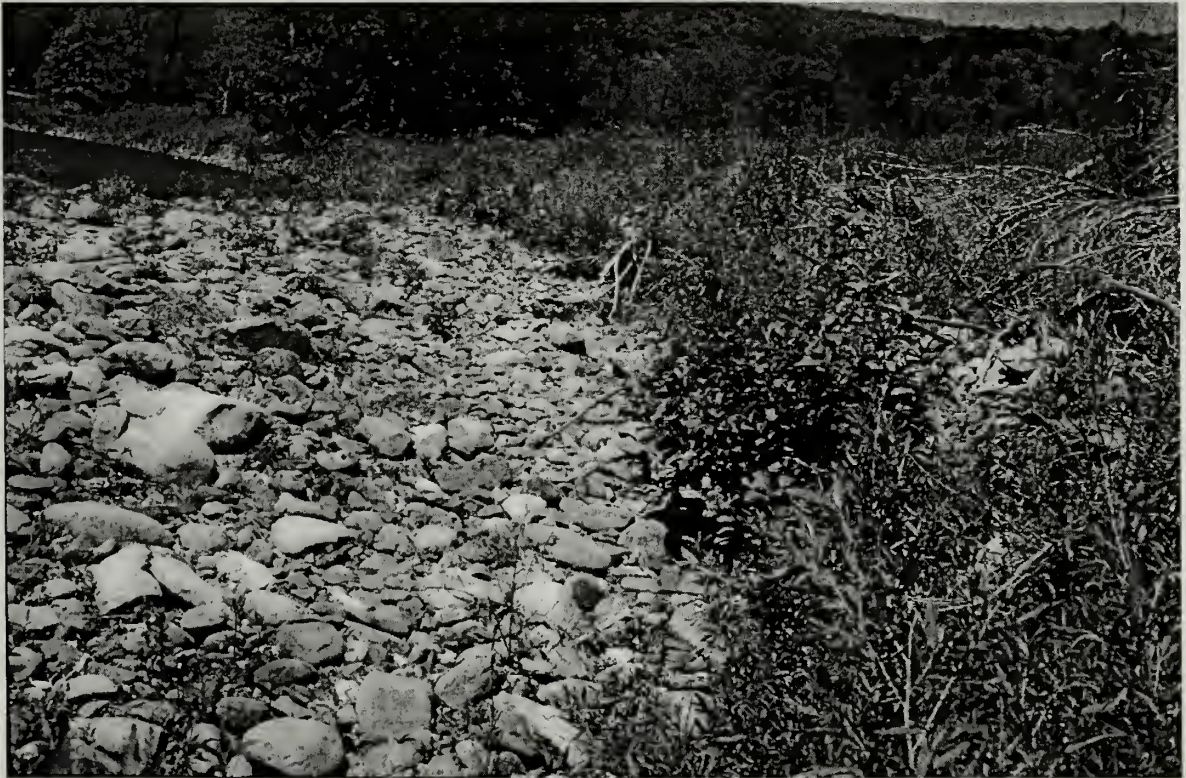
**Photo 39: Transplanted willows at the Ferguson revetment.**

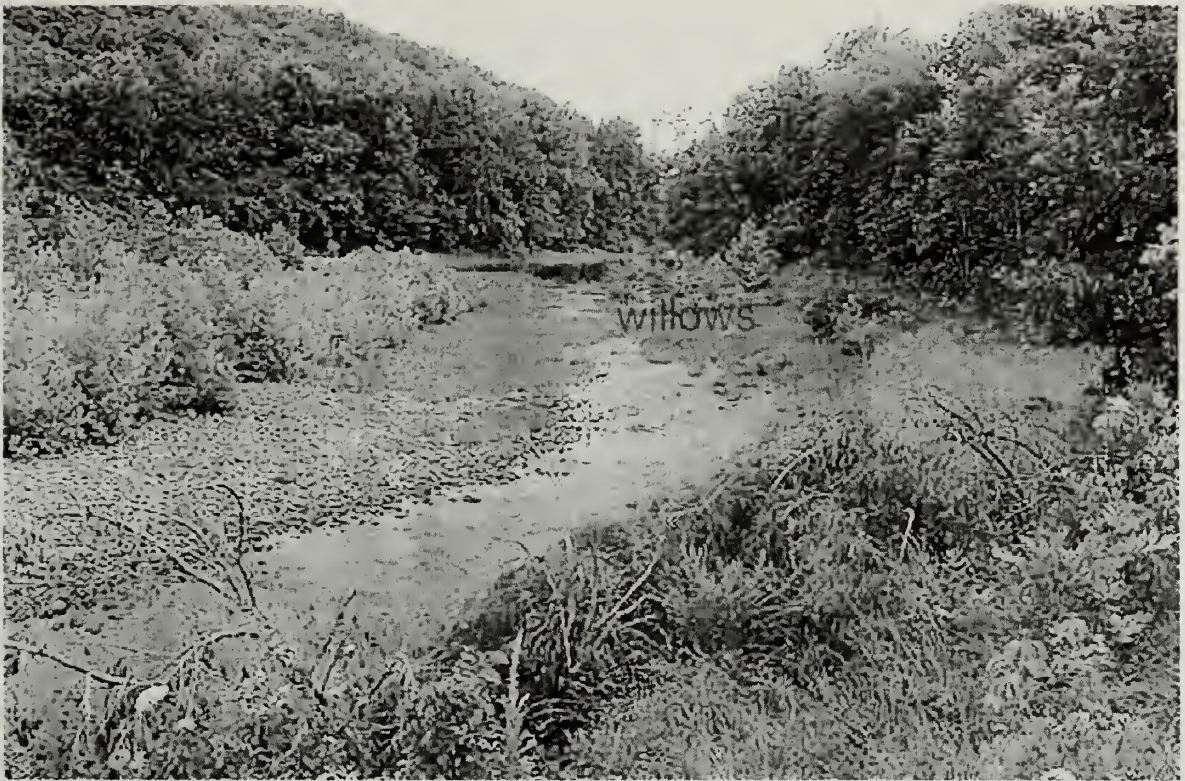
**Photo 40: View looking upstream of willows transplanted to spawn gravel bars.**

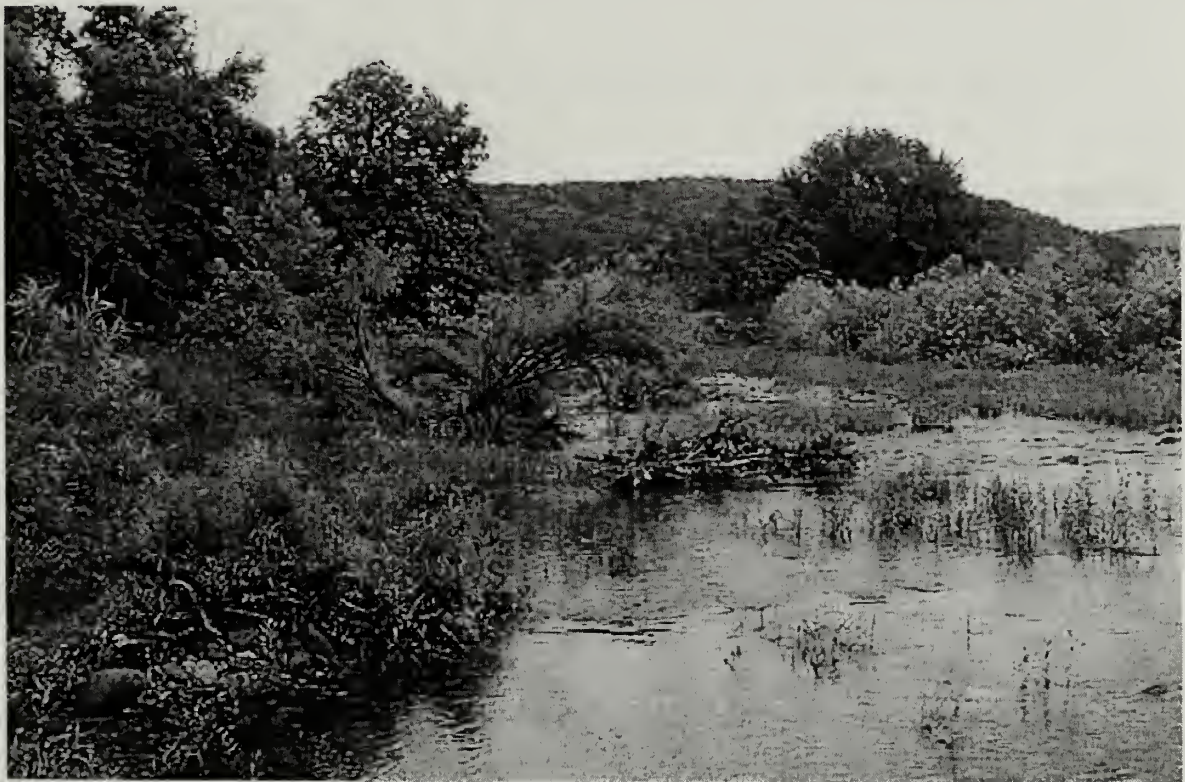
**Photo 41: View looking downstream of willows transplanted to spawn gravel bars.**

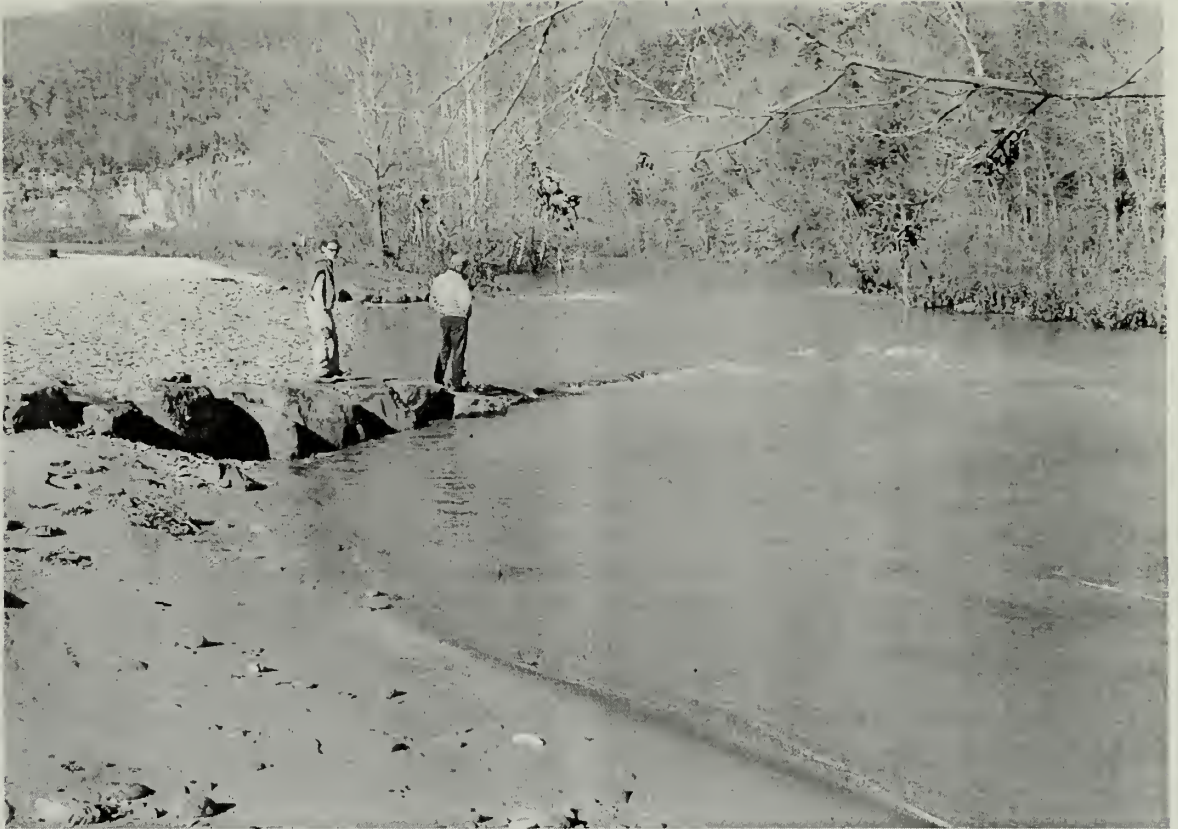
**Photo 46: Rock vanes on Buffalo River near Steel Creek after flood exceeding bankfull flow. View is up stream, note a) shifted thalweg b) pour-off directed toward thalweg, c) near zero velocity and turbulence near bank, and deposition of fine sediment between and below the vanes.**
